Manhole Inspection Summary

Manhole # S11EE2034MH

Insp Date: **8/2/06 10:40 AM**

Location Address: **2224 CREST RD**

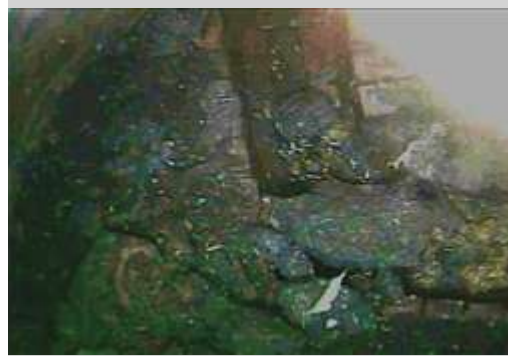
Top View

Bench and Channel debris.

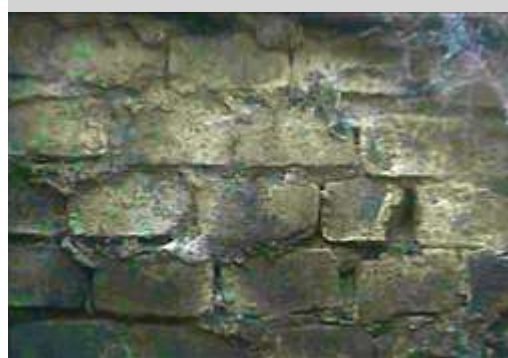
Defect

Condition: ☐ Sound ☐ Cracked ☐ Root Intrusion ☐ Loose Brick ☒ **Deteriorated**

Infiltration: ☐ None ☐ Joint ☐ Cracks ☒ **Mortar** ☐ Roots ☒ **Wall**

Barrel deterioration and infiltration.

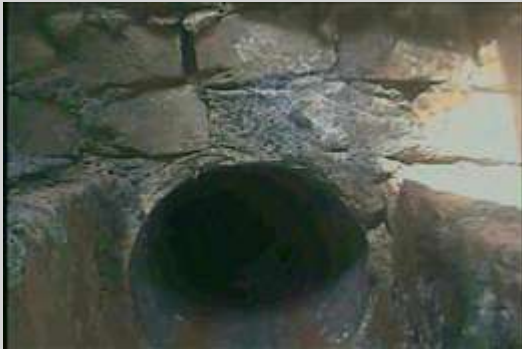
8 in. Circular Gravity Sewer Pipe Out @ 12 O'Clock

Infiltration: **Evidence** Pipe Seal Cond: **Cracked**

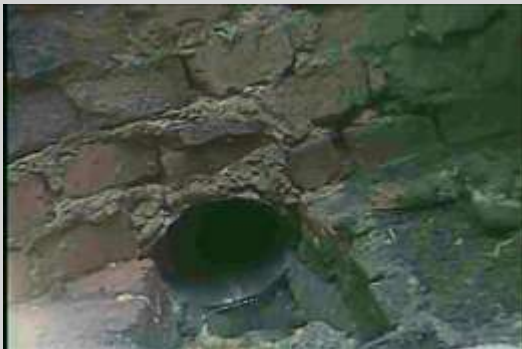
6 in. Circular Gravity Sewer Pipe In @ 3 O'Clock

Barrel deterioration and infiltration. Channel deterioration.
